Inspection Report Minerals Regulatory Program Date May 24, 2010

Permit Number: S/039/0027

Mine Name: Todd Wilhite - Mt. Pleasant

Purpose of Inspection: The Division had been notified that Todd Wilhite was operating a stone quarry East of Mt. Pleasant with out a mining permit. The purpose of the inspection was to verify this and if confirmed, write a cessation order (CO)

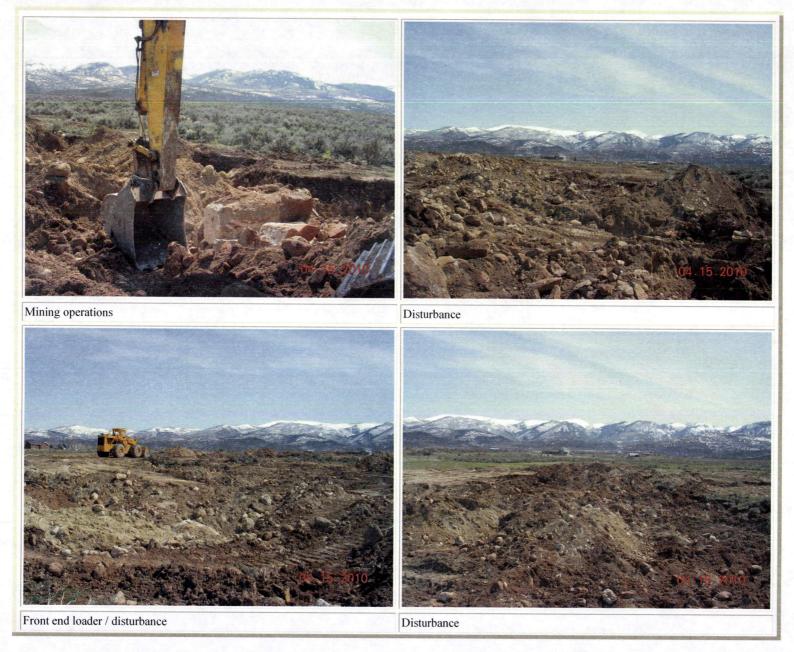
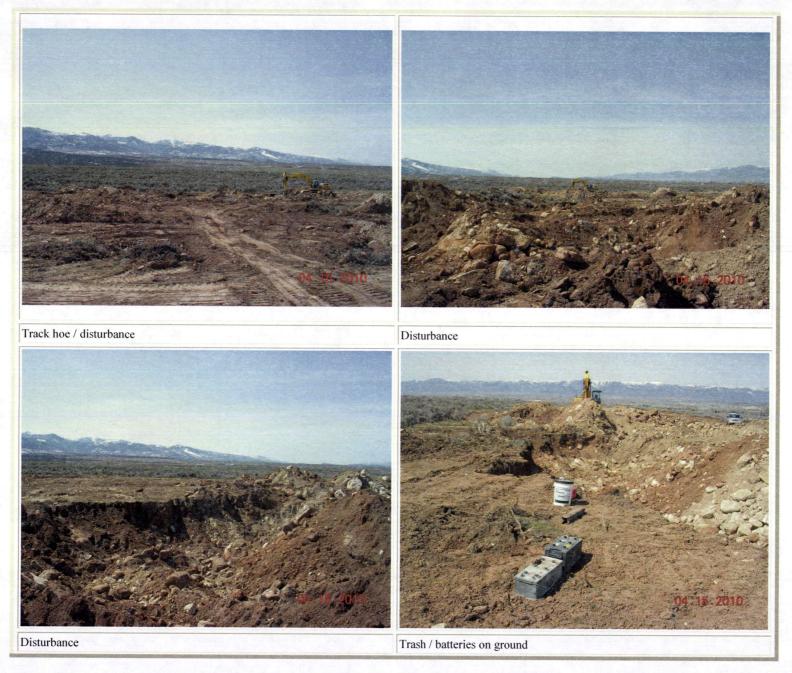
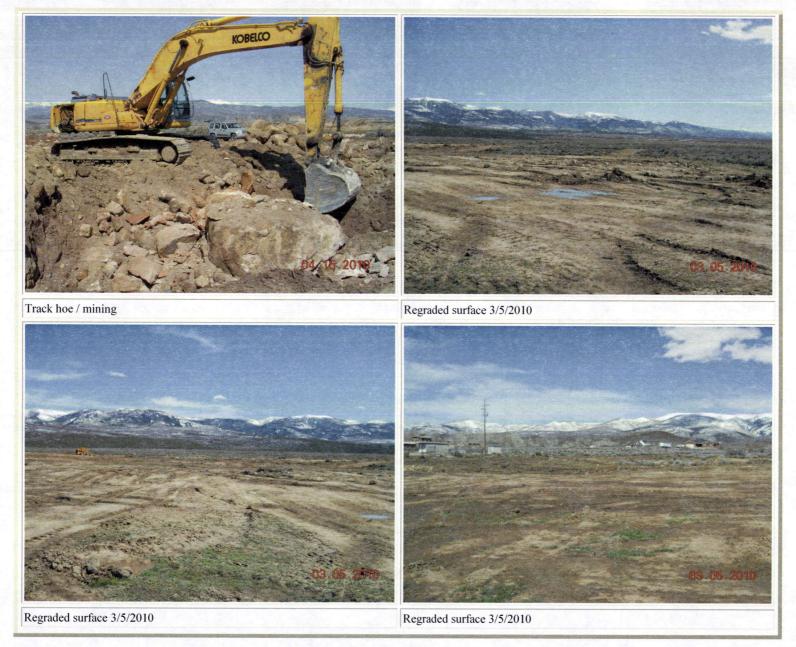
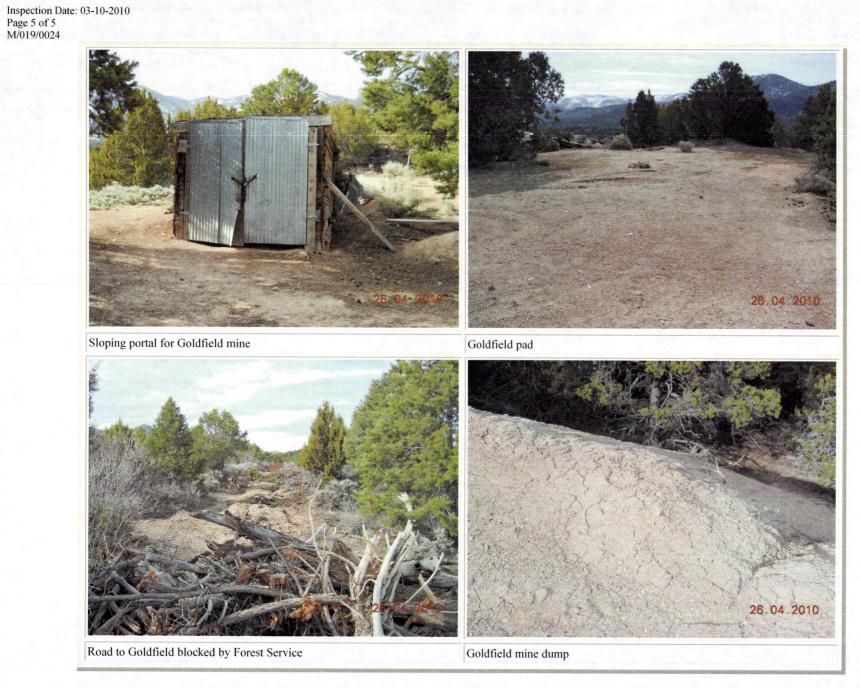
The quarry comprised several small (15–50 ft diameter) exploration pits and trenches 3-5 feet deep scattered across the area searching for landscape rock (2-3 ft. in diameter). There was no central pit. The equipment on site consisted of two large track hoes and a front-end loader. There was trash and deleterious material scattered about the area. Pictures were taken (4/15/2010) to document the current conditions.

Secondary Note: A follow up inspection on May 3, 2010 showed that the area had been almost completely regraded. Pictures were taken (5/3/2010) to document the reclamation process. Therefore, with the positive effort by Mr. Wilhite, he was given an extension until June 8, 2010 to post his revegetation bond of \$5000 bond OR get an approved mining permit, surety bond and reclamation contract so that he may continue mining.

Mr. Wilhite must immediately stopped mining and either get:

- 1. An approved mining permit with a surety bond and reclamation contract, OR
- 2 Begin reclamation immediately of the area and post a \$5000 bond for the revegtation of the area.
